# Manhole Inspection Summary

Manhole # S35AA\_009MH

**Inspection** ☐ Is Incomplete Rating: **3) Fair**

**Location** Address: **208 read st**

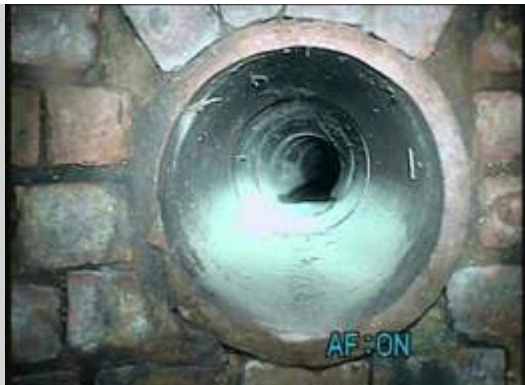
3 O'Clock Inflow

8 in. Circular Gravity Sewer  
Pipe In @ 3 OClock

Invert Depth: **8.92** (ft.) Flow Characteristics: **Fast**

Infiltration: **None** Pipe Seal Cond: **Unknown**

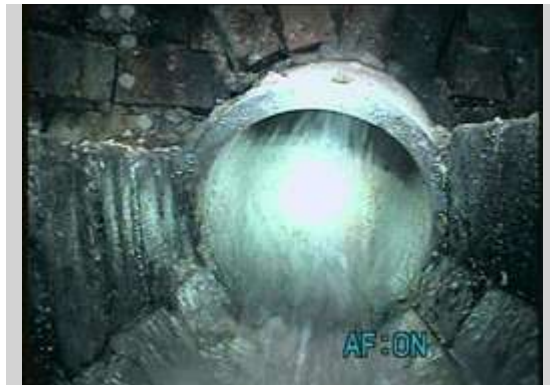
Drop In @ 3 OClock

Drop: **Outside Direct**

Drop Condition: **Open**
